appendix B public meeting minutes

Medford Open Space & Recreation Plan 2011 Update
Public Hearing #1 - April 6th, 2011
Public Comments

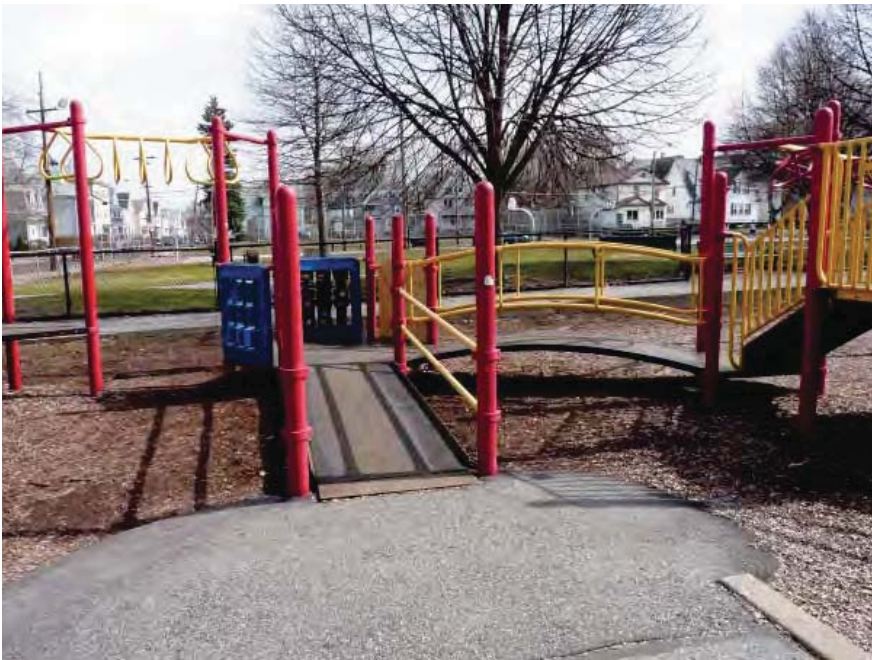
Existing Conditions Photo A

Cracked surface at Basketball court

- Improve ADA access park-wide
- Provide trees for shade further in park by seating areas
- Refurish tables and replace missing top
- Repair cracked Basketball court surface
- Top off mulch in play area

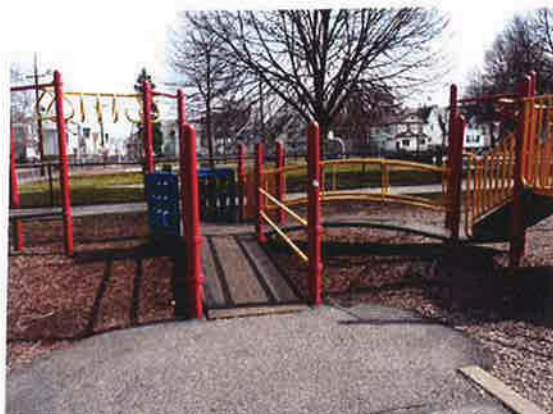
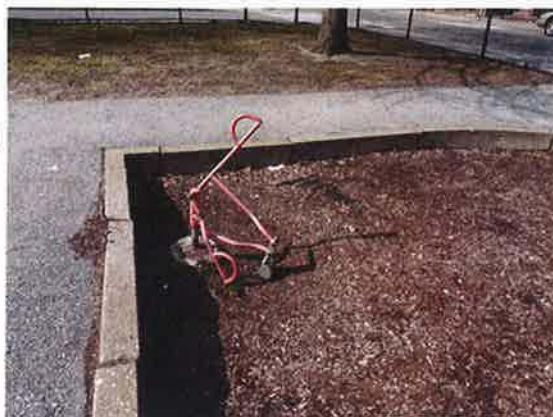
Key	Barrier	Mitigation	Cost
(A)	No designated HP parking spaces	Create * Across from #51 and #11 Marston HP parking adjacent to at least one major park entrance	\$1500
(B)	No accessible route to tennis courts	Create accessible route (curbcut and grade) to tennis court	\$1000
(C)	Picnic tables and water fountain are not accessible	install accessible picnic table and water fountain.	\$6000
(D)	wood mulch in play areas is degraded	Refill wood mulch in play areas to a level adequate to ensure safety + accessibility	\$1800

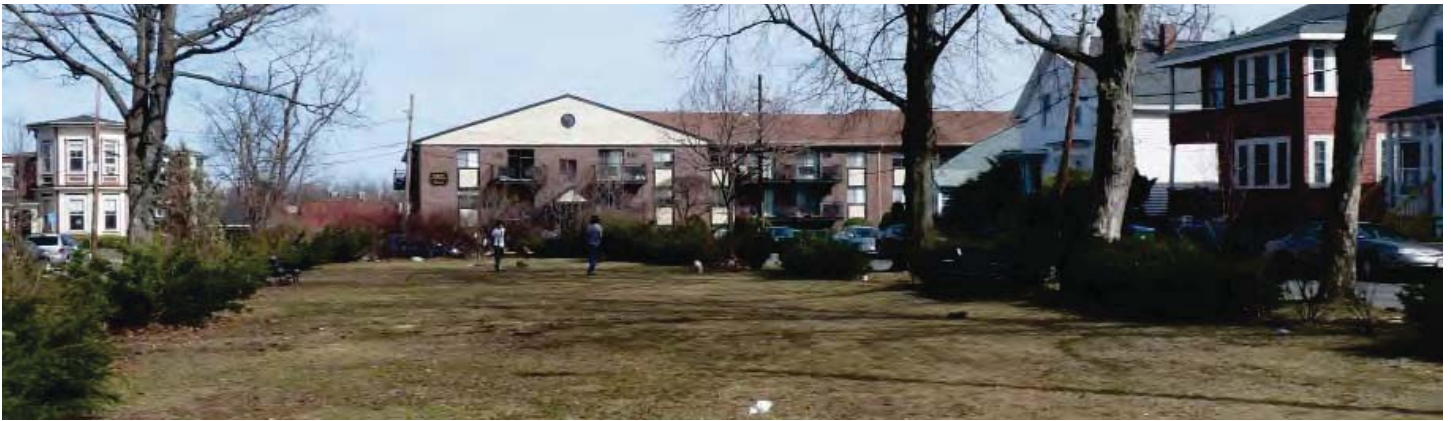
Existing Conditions Photo A

Several trees at the site have been damaged.

- Have all trees evaluated for safety and health. Remove or prune as necessary. Replace where required.

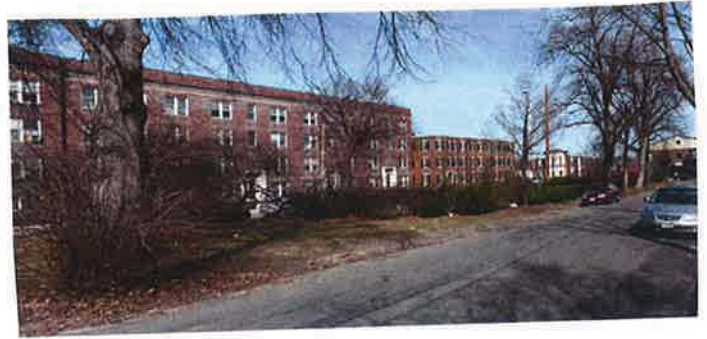
Key	Barrier	Mitigation	Cost
(A)	No accessible entrance into the site	Create an accessible route into the park (hard-packed + even surface, accessible slope)	\$7,500

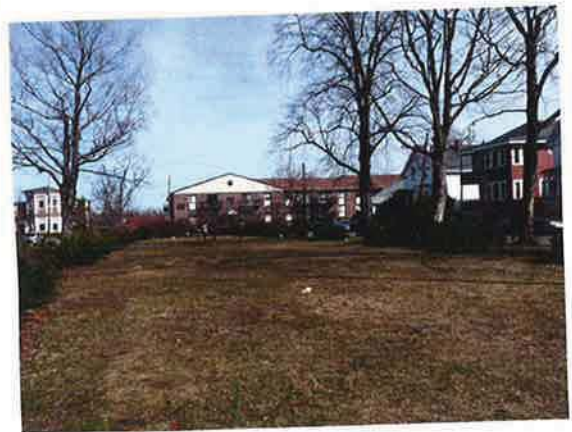
(B)	No site amenities - accessible or otherwise	Install accessible site amenities - benches (2) and/or picnic table (1)	\$1,000
-----	---	---	---------

(C) HP (P) X2
 w/ HC curbs
 # DAMPS \$3,600

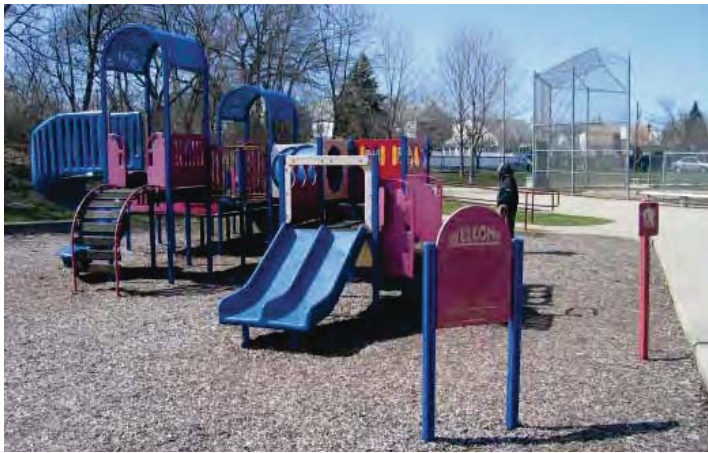
Existing Conditions Photo B

- Play equipment in fair condition, some minor aesthetic degradation (fading & wearing of paint)
- bark mulch has decomposed/compressed to be approximately 1' lower than necessary for safety & accessibility.

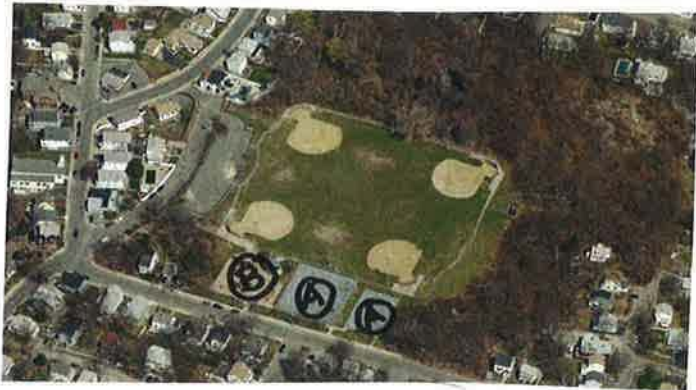
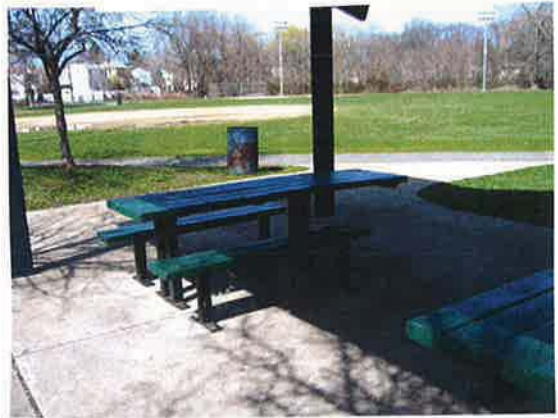
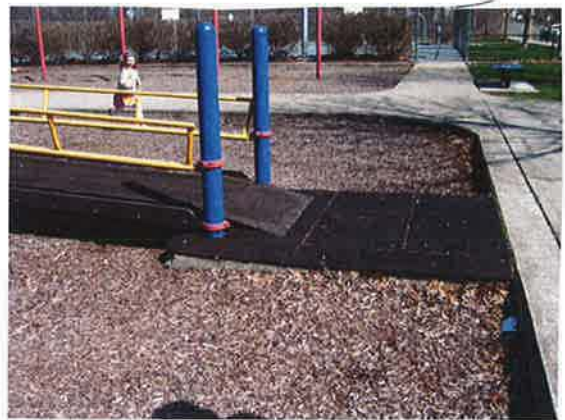
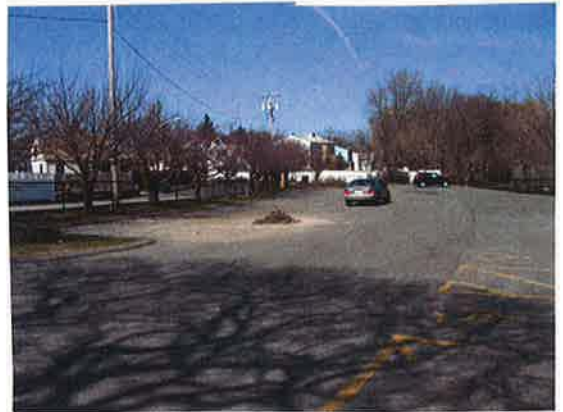
Court surfaces in need of repair but accessible routes to each of the courts exists.
Wood chips in playground need to be replenished

Key	Barrier	Mitigation	Cost
Ⓐ	Court surfaces Cracked, uneven, potholed	Resurface courts	\$25,000
Ⓑ	Wood chips in play areas degraded	Replenish wood chips in play areas	\$500

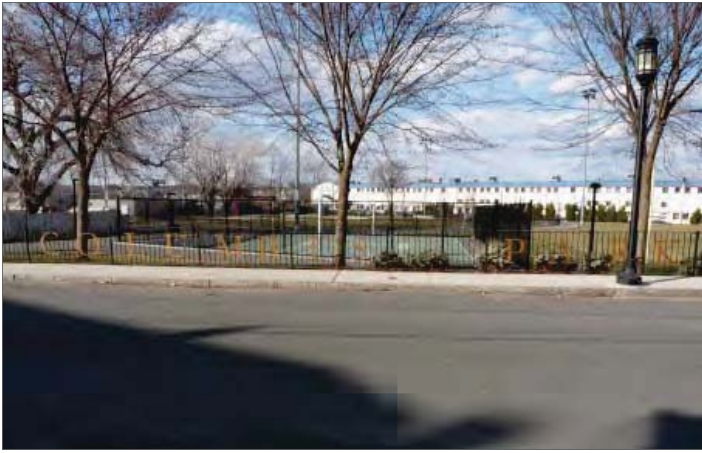
Existing Conditions Photo A

Basketball court in good condition, nets degraded.

Fields in good condition. Lit for nighttime use. Playfield grass cover has some thin patches.

- Patch rubber poured-in-place in playground where worn through.
- Other improvements as deemed necessary by City officials and neighborhood stake holders.
- Repair playing field grass cover where needed.

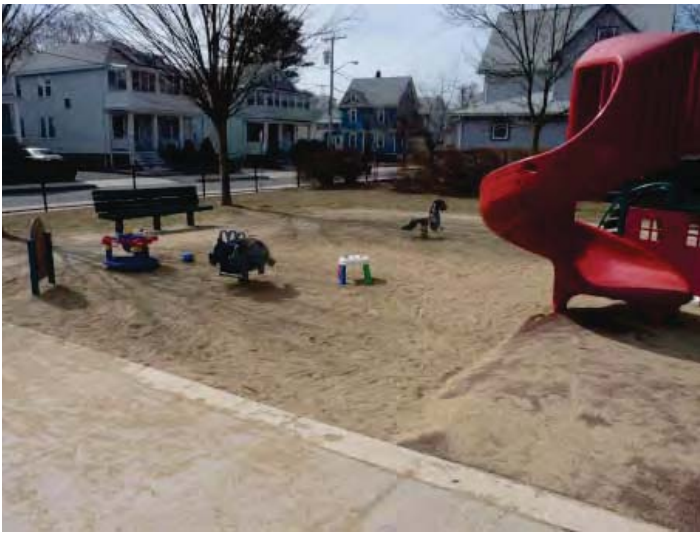
Existing Conditions Photo A

Lawn, shade trees and some shrubs - in fair condition.

- Re-grade and refill sand in the play areas as necessary to reach surface levels of surrounding pathways and rubber poured-in-place access points.

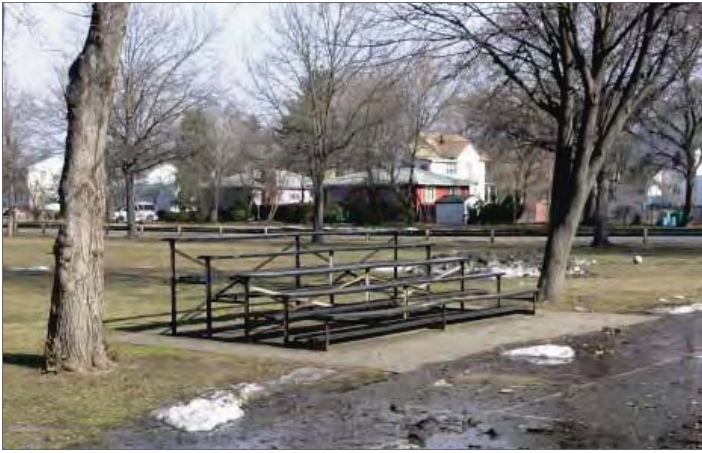
Existing Conditions Photo A

Basketball court surface starting to wear, tennis courts and fencing in good condition. Seating for basketball court needs replacement.

- Create formal accessible pathways throughout the park.
- Resurface Basketball court.
- Replace/add seating throughout.
- Prune existing shade trees
- Other improvements as deemed necessary by City officials and neighborhood stake holders.

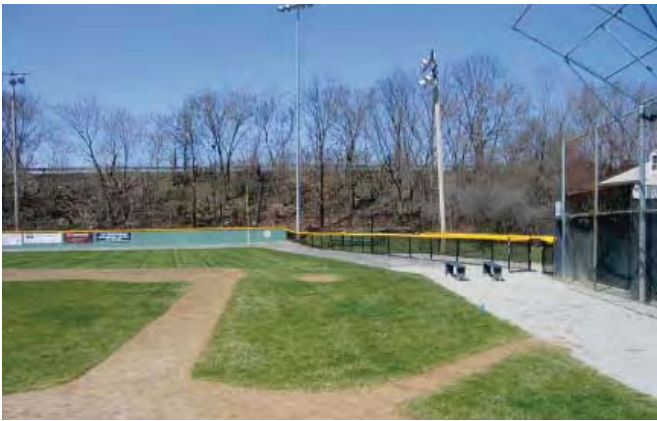
Existing Conditions Photo A

- Kept in excellent condition by volunteers and sponsors.

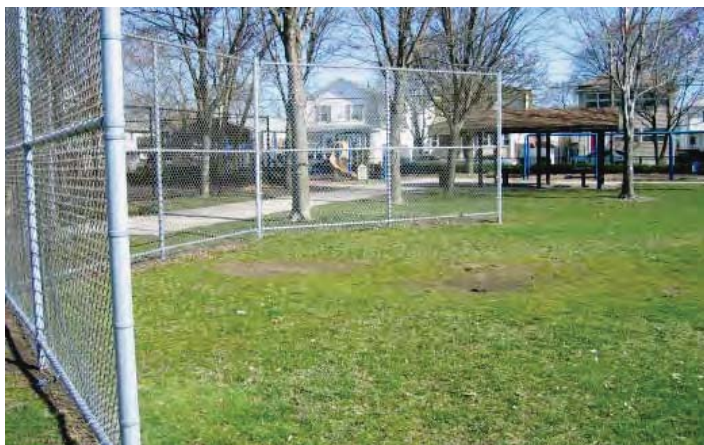
Existing Conditions Photo A

Large open area extends between baseball and soft-ball, large and numerous cracks on joined tennis/bball and hockey courts, tennis net and posts missing, baseball diamonds completely overgrown with grass, large depressions at plate areas.

- Weed and replace / input new sand surfacing @ baseball diamonds

- Repair depressions at baseball diamonds

- Replace net at tennis court

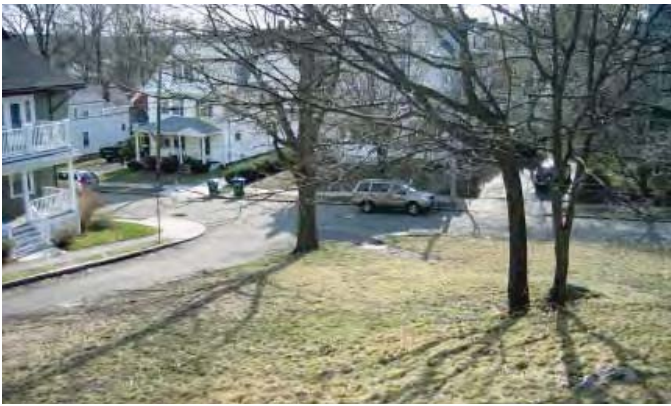
Existing Conditions Photo A

No paths through the park. Several entrances with steps up into the park, but asphalt at entries is completely overgrown. At SE corner and on the N side are "ramp" entries, but asphalt is bumpy, cracked, and ends about 10' into the lawn area - no truly accessible entrances.

- Broken glass in large amounts at top of the hill by tower. Clearly used by neighbors, but broken glass is evidence of unwanted nighttime activity:
 - Removal of glass
 - Improve lighting to increase security, but limit light impact on neighbors
 - Improve a couple of key access points to provide ADA entry and safe/clear stair entry.
 - Repair stonework: retaining walls and stairs.
 - Maintain “rustic” and “historic” quality of the park in any improvements
 - Consider installation of simple (stone-dust, crushed gravel) path up to tower to minimize foot traffic impact on lawn and ledge.
 - Informational signage/plaque on history and purpose of tower/park, and park sign
 - Other improvements as deemed necessary by City officials and neighborhood stake holders.
-

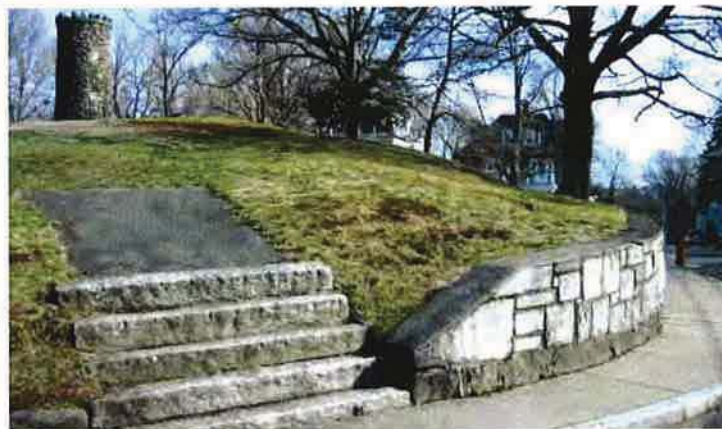
NO ENTRY WAY RAMP, HANDRAIL

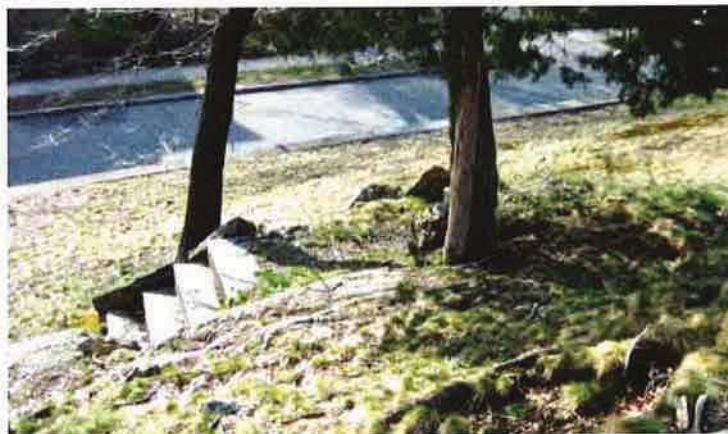
BROKEN STEPS, LEADING TO ROCKS, TREES

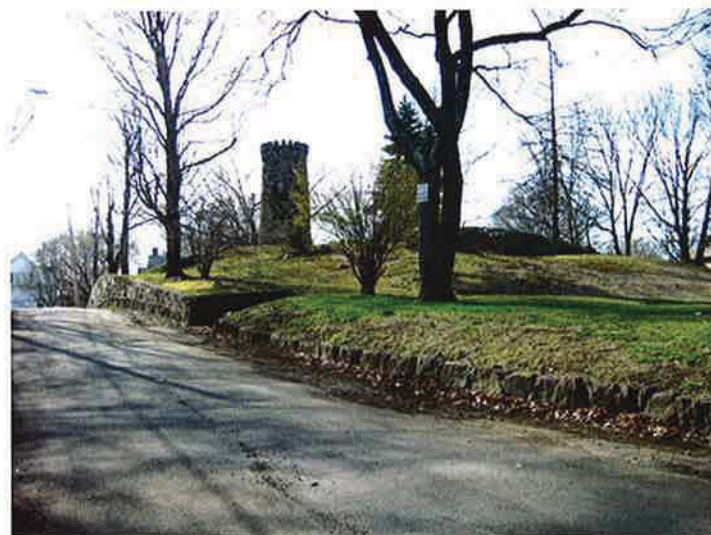
NO DESIGNATED PARKING SPACES

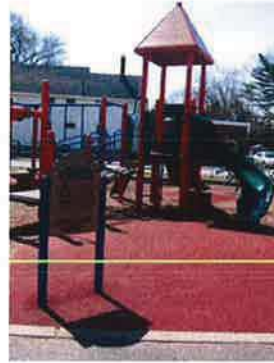
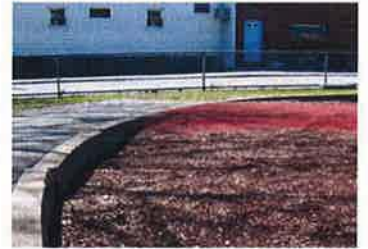
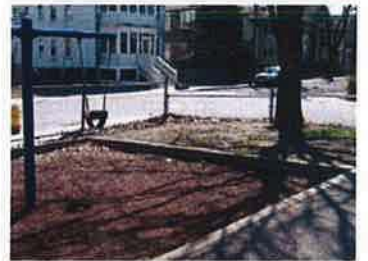
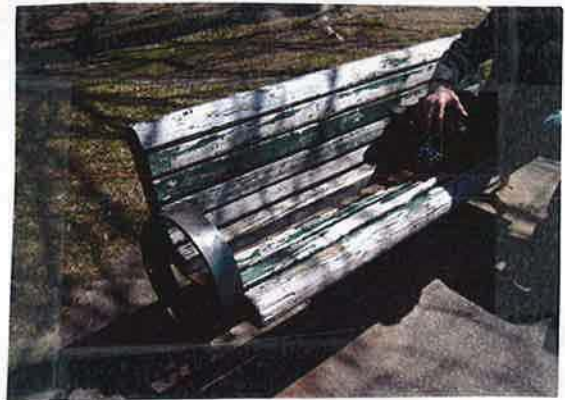
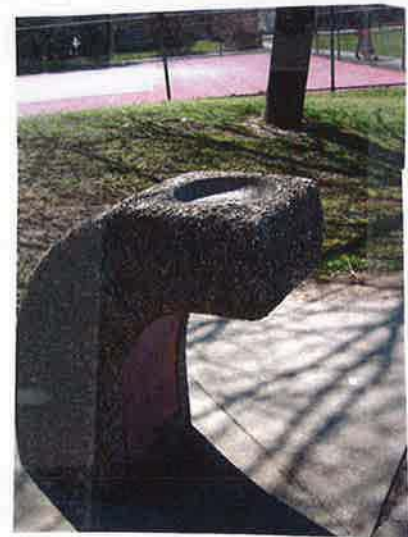
Playground has PIP accessible routes to the climbing structure. Wood chip safety surface needs replenishing at climbing structure and at swings.

Key	Barrier	Mitigation	Cost
A	Accessible Parking	Install detectable warning strip, signage, & min. 2 HP spaces.	\$1000
B	Accessible Play Structure + SWING	Refill wood chips. ADD SWING	\$500 \$500
C	Accessible Pathways to all elements	Provide paved surface to baseball field from HP parking & other site features.	\$3,000
D. REPLACE BENCHES X2			\$5,000

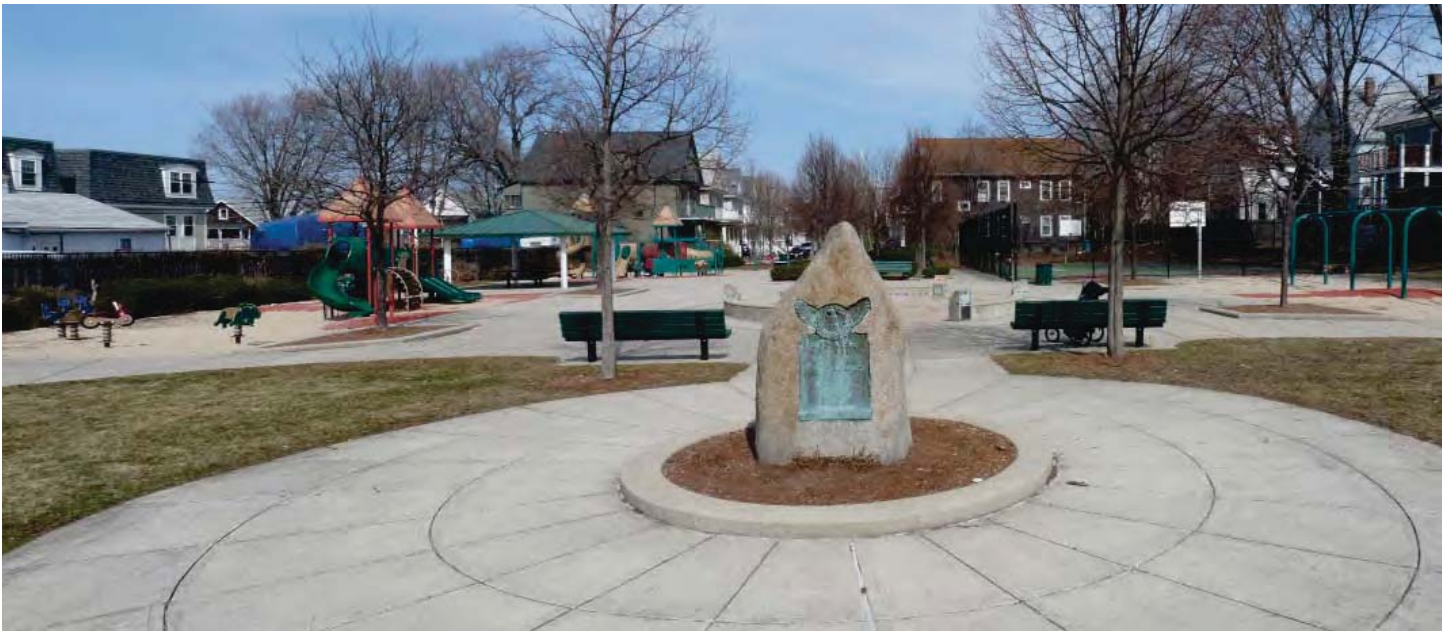
Existing Conditions Photo A

there is a splash area with spray features. Basketball nets are worn & ripped.

- Refill sand in play areas to necessary levels, or replace with new safety surfacing material
 - Replace the missing ADA swing
 - Inspect splashpad area for functionality. Repair as necessary.
 - Other improvements as deemed necessary by City officials and neighborhood stake holders.
 - Add HP parking at Capen Street entrance.
-
-
-

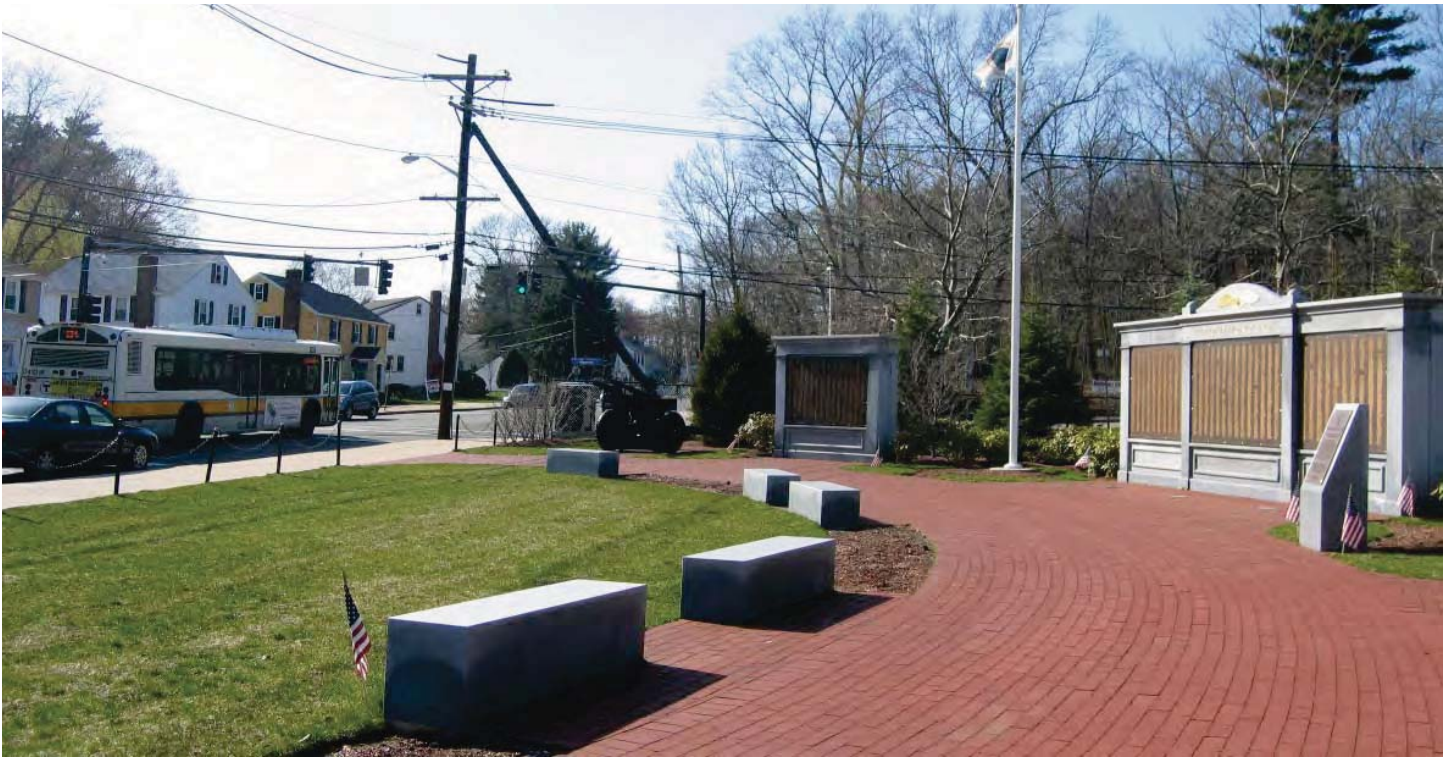
Existing Conditions Photo A

Pathways: brick, in good condition

Fencing: metal poles with chain, painted black, in good condition.

- The park is less than 4 years old at the time of this report, and is in excellent condition. No maintenance needs were noted.

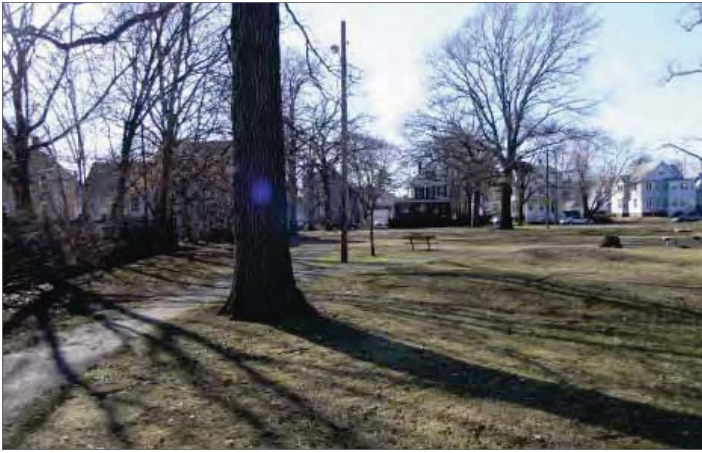
Existing Conditions Photo A

- play area gate broken

- add additional ADA play features
- upgrade all site furnishings
- fill in play area ground surface with either mulch or poured in place and remove wood edging + fencing
- Replace sand
- fence park edges instead of individual play elements to create a more open environment within the park
- add play equipment for younger children age 2-5 years.
- integrate play into earthwork area
- Other improvements as deemed necessary by City officials and neighborhood stake holders

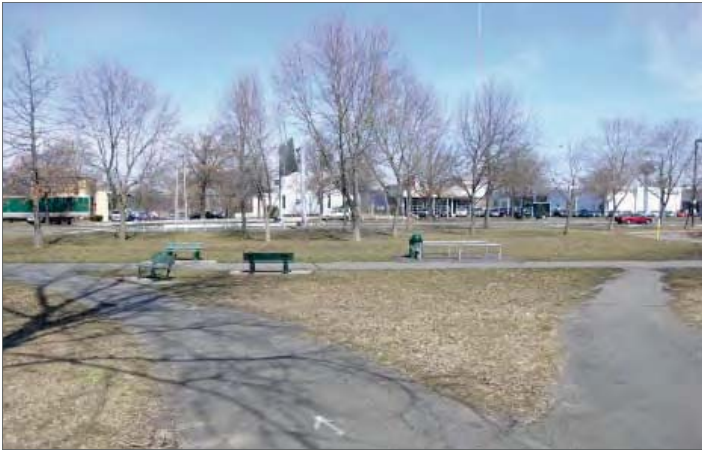
Existing Conditions Photo A

- Connection to west side of Mystic Reservation could be improved.
- Condition of paths along Parkway need improvement
- wooden bridge on eastern side of park is not ADA compliant.

- some invasives present (ex: Phragmites)
- waterfront edges are overgrown in some areas, in others are open to degradation due to plantcover damage.

- Repair/replace benches
- Prune or remove damaged trees, replace removed trees with a diversity of tree species - consider an “arboretum-like” approach.

- Make planting & materials improvements to the Mystic Valley Parkway median along the park’s edge, to establish a strong corridor and enhance the “parkway” identity.

- make accessibility improvements to paths & bridges.
- add educational signage and activity potential
- repair/replace existing fishing pier
- Other improvements as deemed necessary by City officials and neighborhood stake holders.

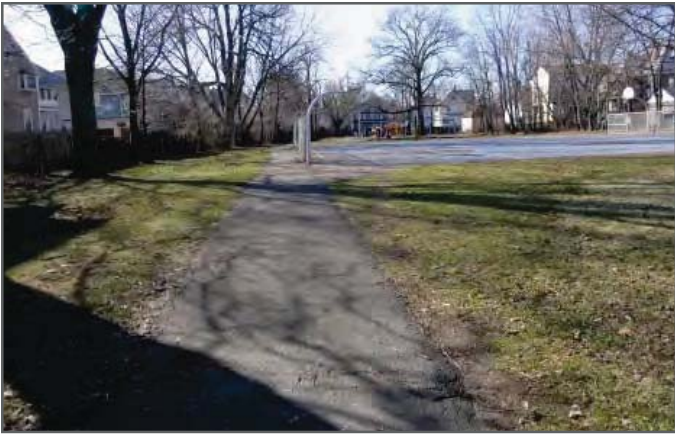
Existing Conditions Photo A

- Deteriorated painted surfaces on basketball court, cracked in places

- All park benches are damaged

- All rocking toys are damaged or missing

- General maintenance and upkeep - broken glass near the play areas

In general the site is in poor condition. Existing pathways are degraded and cracked. Courts and lawn areas are in need of refurbishment. The play area is unsafe and complete inaccessible.

- Playground in need of repair and/or replacement, inclusion of accessible elements for improved ADA compliance.
- Surface of play area needs replacement, accessible surface needs to be installed in at least some areas.
- Resurface & sealcoat basketball courts
- Prune existing shade trees
- Remove invasive vegetation
- Install new park seating/benches and site furnishings
- Other improvements as deemed necessary by City officials and neighborhood stake holders

A full park renovation is recommended including but not limited to: complete perimeter circulation, replacement of all play elements and site furnishings, replacement of court surfacing and appurtenances.

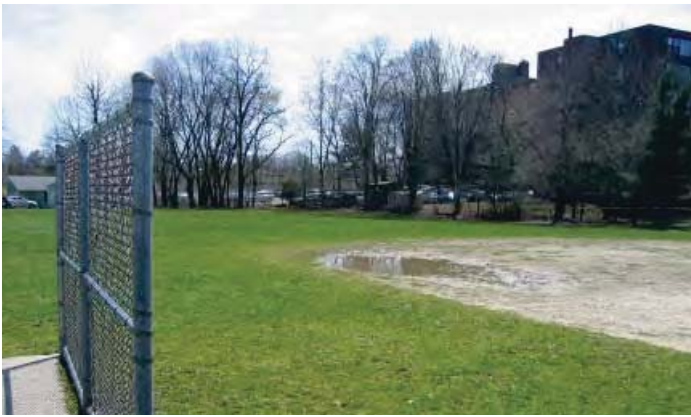
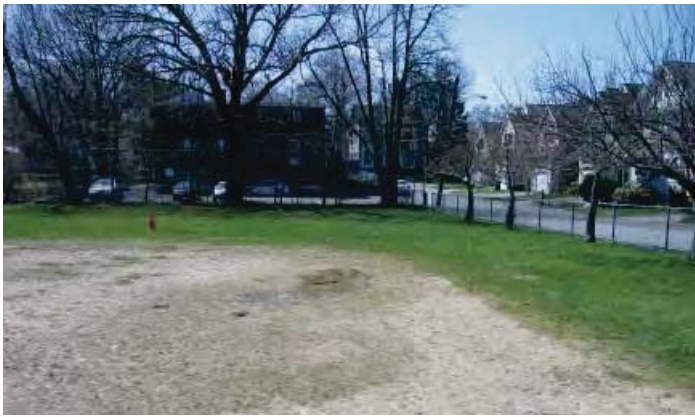
Existing Conditions Photo A - baseball diamond

Existing Conditions Photo B - baseball diamond

- replace all elements in south play area, remove north play area completely
- redesign circulation
- clean up trash, broken bottles, broken equipment/features in south play area.
- add security light in south play area, generally increase visibility into the site.
- refurbish turf and infield at ball field, fill low areas
- prune existing mature trees to improve overall safety and aesthetics of the site
- Other improvements as deemed necessary by City officials and neighborhood stake holders.
- McNally Rock should be relocated to a more prominent position within the park.

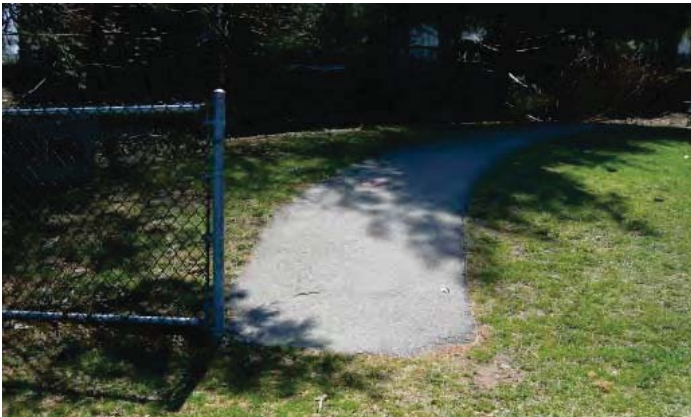
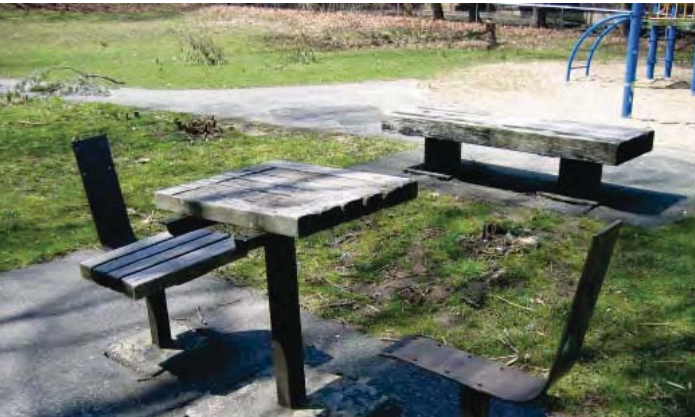
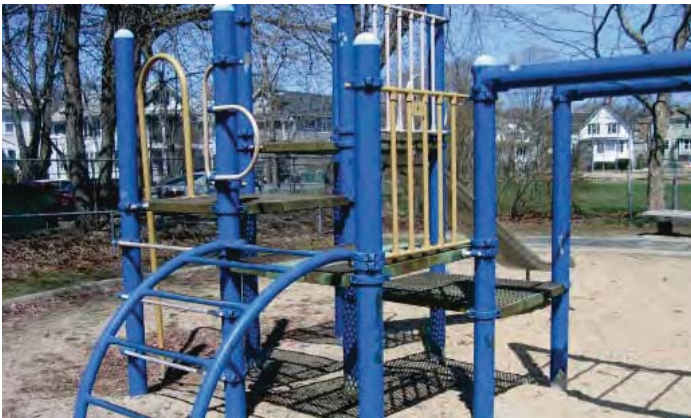
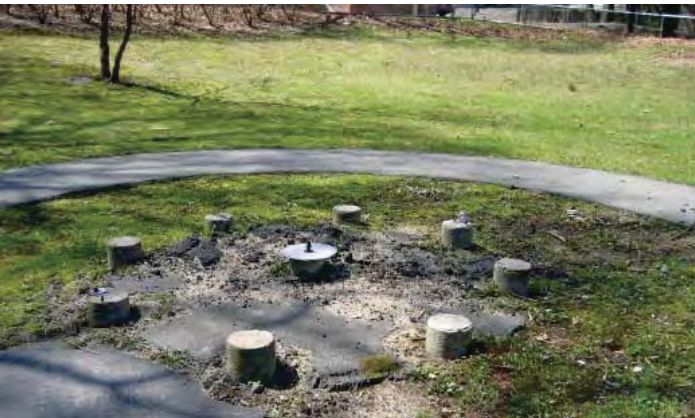
play equipment paint failing, rust, sand area needs refilling and weeding benches and tables decomposing, have been torn apart in the same places broken bottles, pathway from street covered in leaves and tree litter - no evidence of maintenance in years.

Existing Conditions Photo C - south play area

Existing Conditions Photo D - south play area

Existing Conditions Photo E - south play area

Existing Conditions Photo F - south play area

South play should be removed and consolidated into one location to the North of the site with a fully accessible structure and swings. Site furnishings are unsafe and require replacement.

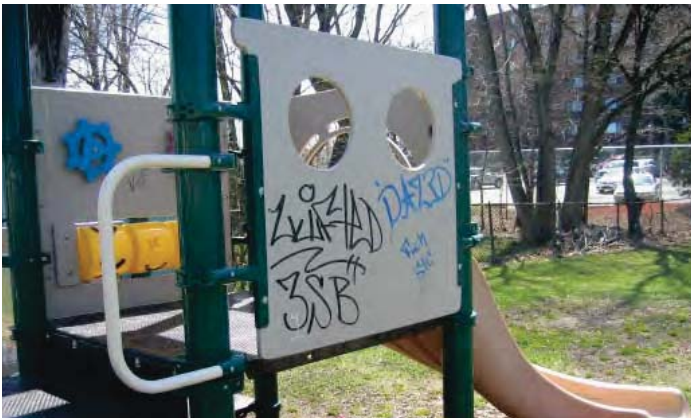
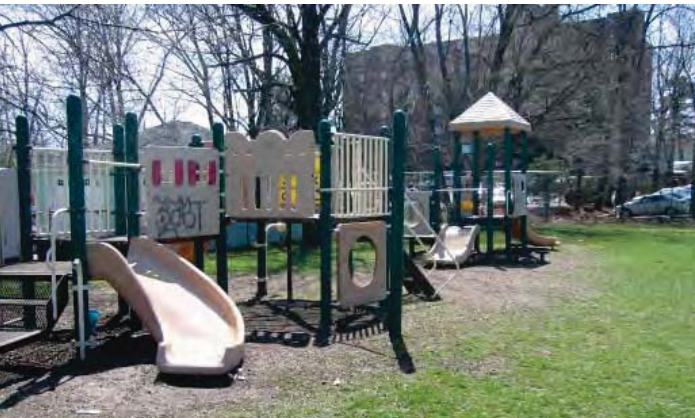
graffiti, paint worn off in places, no nearby seating, no definition of play space, proximity to ballfield.

Existing Conditions Photo G - east play area

Existing Conditions Photo H - east play area

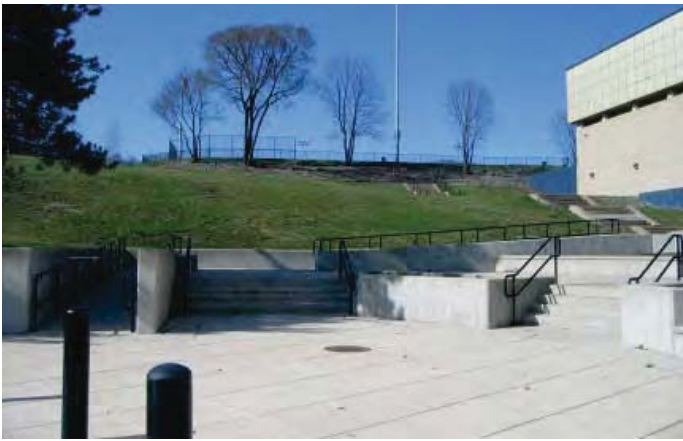
Existing Conditions Photo A

- Natural turf field in poor condition.

- Repair stairs up to fields (drainage & cracking)

- Repair large (SW) natural turf field

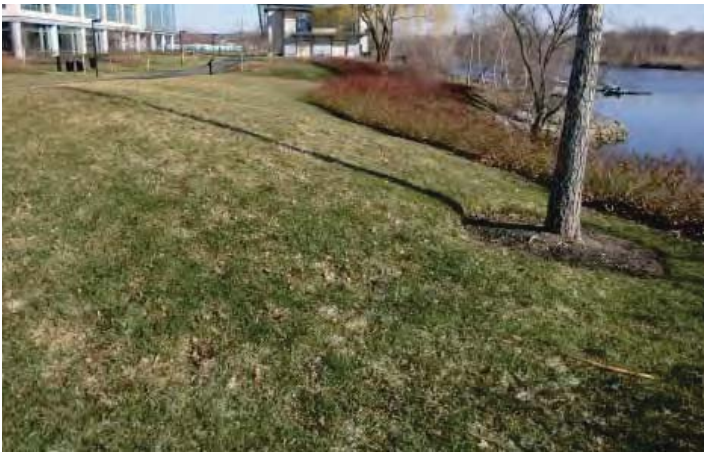
Existing Conditions Photo A

All in good condition. Ample seating. Trash & recycling receptacles at entrances.

- consider adding directional signage at Wellington Station.

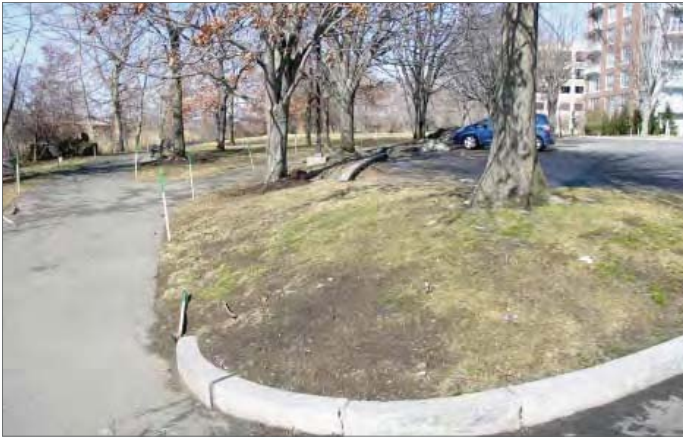
Existing Conditions Photo A

Not well lit in areas near T tracks. One half (east-
ern side of the park was recently renovated. Older
areas (western side) have degraded seating & picnic
tables.

- East side of park needs renovation- older benches, picnic tables.
- Boat ramp signage at Fellsway would be helpful.
- Inspect & prune trees
- Remove invasives along river bank
- Consider a pedestrian bridge under the Rte 28 bridge to connect McDonald Park to the Station's Landing area.
- Push forward with plans for extending path network around Wellington station and to the River's Edge development. Train bridge presents opportunity for community art installation.
- Other improvements as deemed necessary by City officials and neighborhood stake holders.

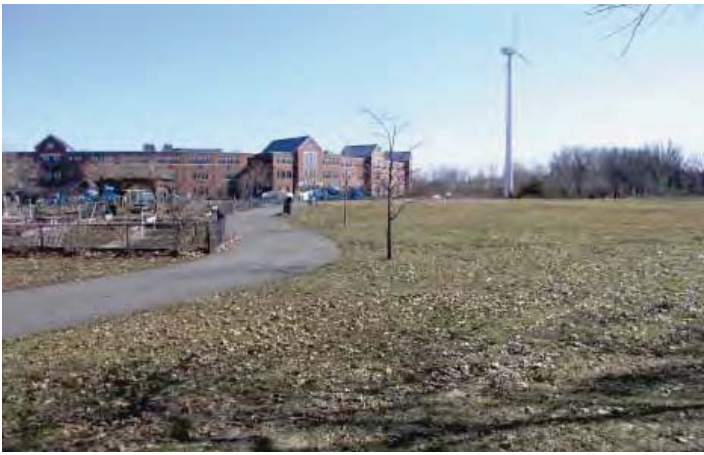
Existing Conditions Photo A

The Mystic River forms the western border of the site. There are several historical and environmental interpretive signs along the Mystic River that have been vandalized and suffered environmental degradation.

- Assess the riverbank vegetation for invasives
 - Assess potential for extending riverside paths north towards the Riverside Yacht Club and Medford Square.
 - Refurbish/replace interpretive signs along the Mystic River.
 - Other improvements as deemed necessary by City officials and neighborhood stake holders.
-
-
-
-

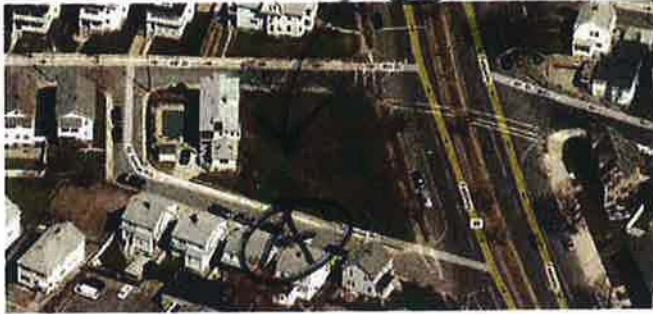
Ⓐ HCP Ⓒ
STREET
SIGN, STRIPE \$1500.
+ CURB RAMP

Ⓑ ACCESSIBLE
ROUTE THROUGH
PARK \$7500

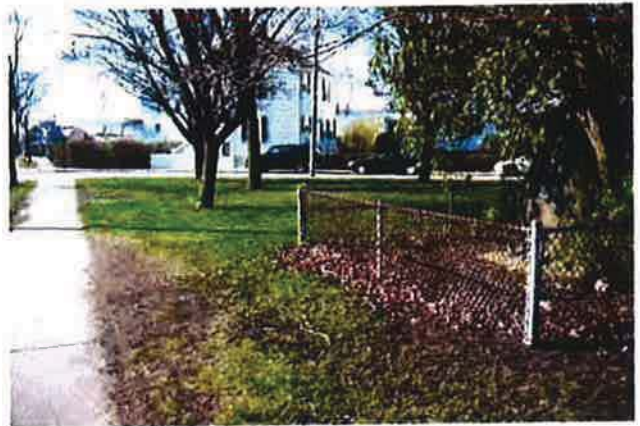
PEDESTRIAN PATHWAYS ARE
LIMITED TO PERIMETER SIDEWALK.

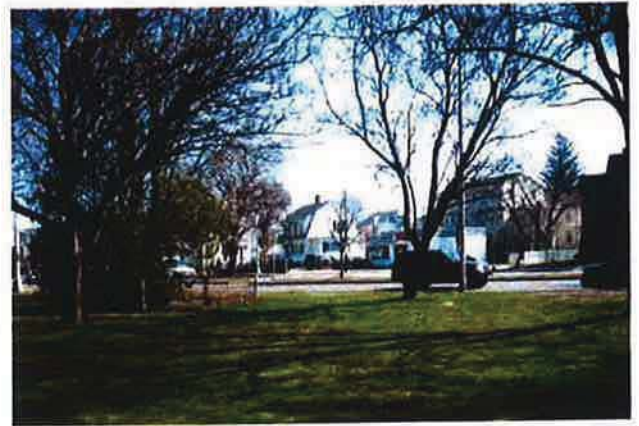
TREE PRUNING WOULD
IMPROVE TREE CONDITIONS.

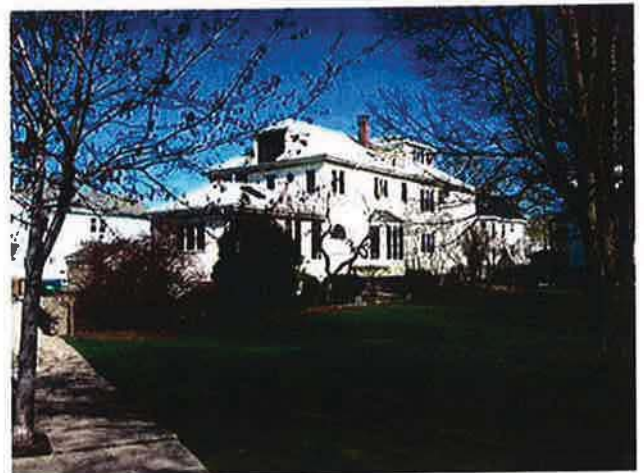
POTENTIAL SEATING AREAS
COULD MAKE THIS A MORE
USER-FRIENDLY PASSIVE
PARK

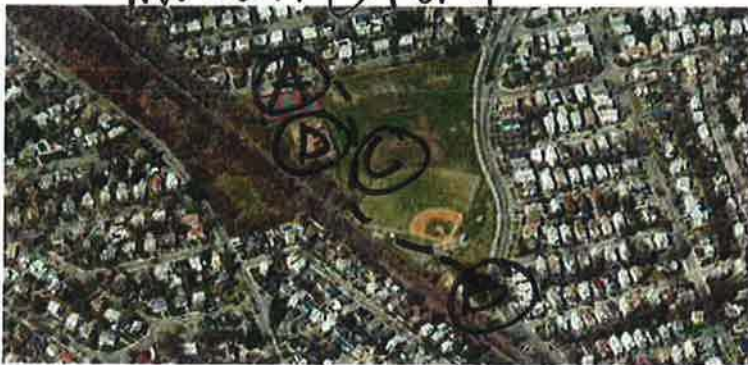
(C) PATHWAY TO
CONNECT SITE \$7,500
FEATURES

(D) REFILL FILLER \$1000
MULCH CRAY

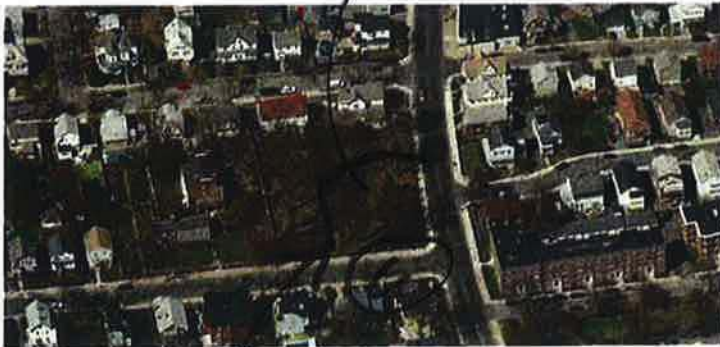
Key	Barrier	Mitigation	Cost
Ⓐ	ACCESSIBLE GATE LATCH		\$500
Ⓑ	ACCESSIBLE GATE PAROVIA FROM TO TEXTURES		\$5000
Ⓒ	HC Ⓐ SPACE W/ CURB RAMP		\$1500

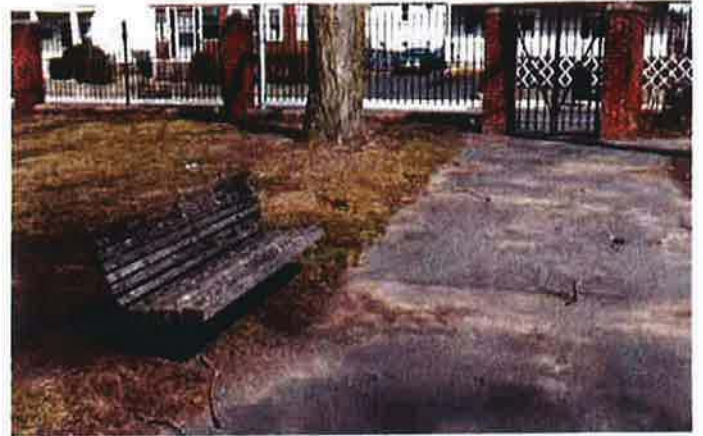
ACCESSIBILITY ISSUES:
CRACKS IN PAVEMENT, UNEVEN PAVEMENT

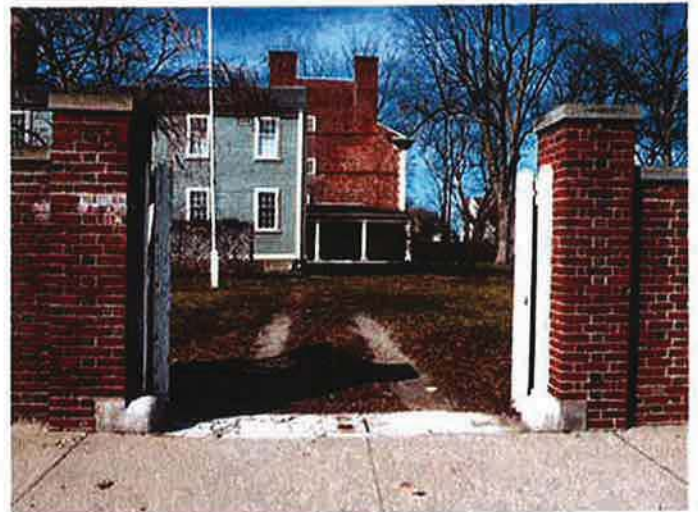
UNEVEN ENTRYWAY PAVEMENT

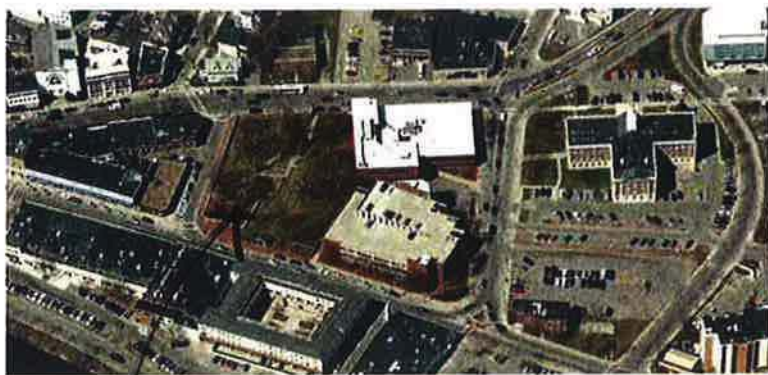
(A)	RAMP @ ENTRANCE TO PLAZA		\$5,000
-----	--------------------------------	--	---------

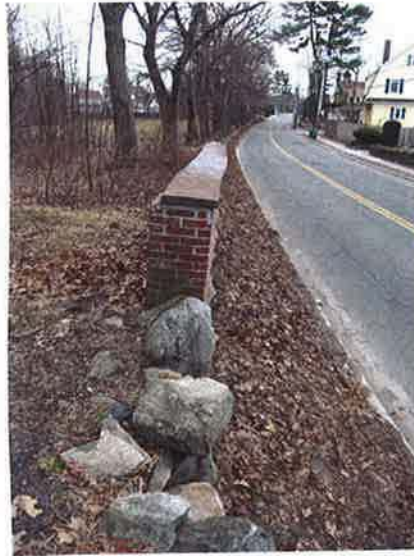
Existing road conditions
Total lack of access, parking evident.

A.	Accessible Parking	designate Spot / Drop off area create curb cut	\$1500
----	--------------------	--	--------

B.	Accessible Path to elements	lay path from new cut to points in park.	\$10,000
----	-----------------------------	--	----------

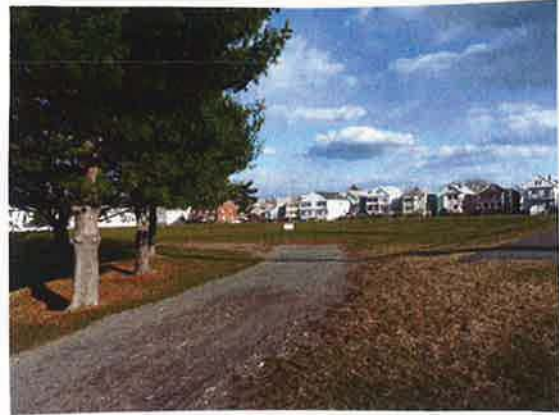
Inaccessible path
A

A Accessible pathway to all elements
 Construct ~580' of accessible paths \$7,500

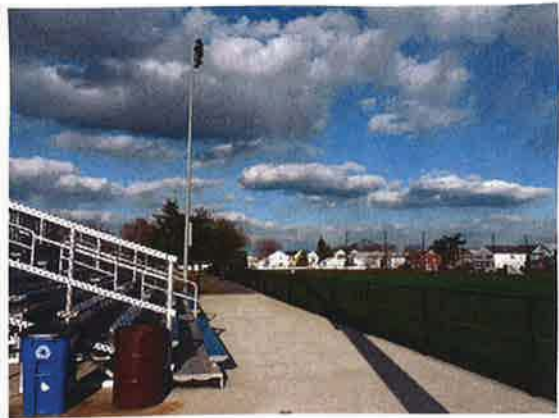
Accessible bleachers

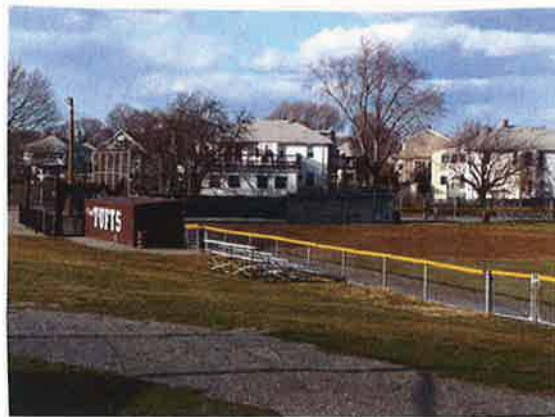
Inaccessible bleachers

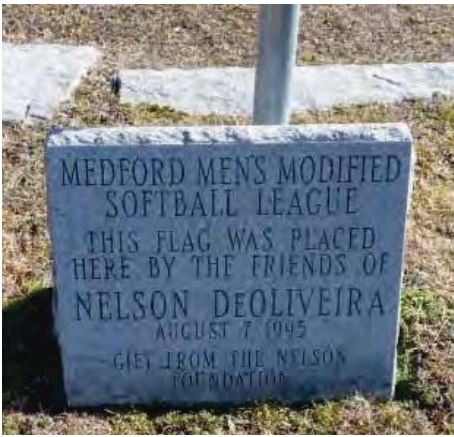
Existing Conditions Photo A

Natural vegetation along the river's edge, generally overgrown and separated from the park area by a chain link fence (fence in poor condition).

- Remove the chain link fence along the river, selectively clear the vegetation to enhance health of vegetation, remove invasives, and improve viewsheds.
 - Create a riverside path to continue the Mystic River Reservation experience. This pathway could tie into paths/paved areas around the diamond backstops and bench areas to reduce the impact of foot and maintenance vehicle traffic on the site.
 - Provide a sidewalk along the Mystic River Parkway.
 - Provide accessible parking with clear signage, pavement markings, and curb cuts. Preferably off-street, as both the Mystic Valley Parkway and Winthrop Street are busy streets with fast-moving traffic.
-

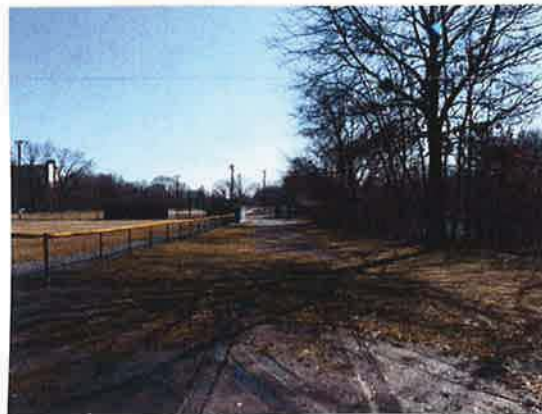
A

Existing pathway conditions along river

re-pave sidewalk along with up 350' **\$5,000**

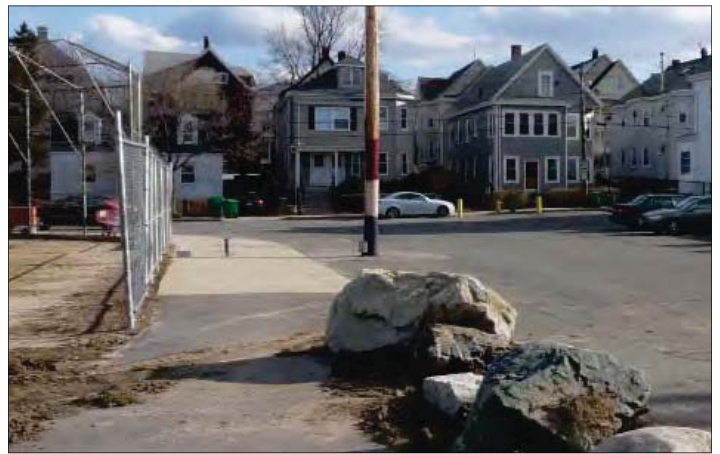
Existing Conditions Photo B - parking & team bench

- Place buffer (vehicular barrier, plantings or rail) between parking lot and team bench at baseball field adjacent to the parking lot.
- detailed pool assessment
- remove graffiti from the play equipment
- top off the sand around the play equipment & swings, or replace with a new material (such as rubber poured-in-place)
- replace the missing accessible swing.
- Other improvements as deemed necessary by City officials and neighborhood stake holders

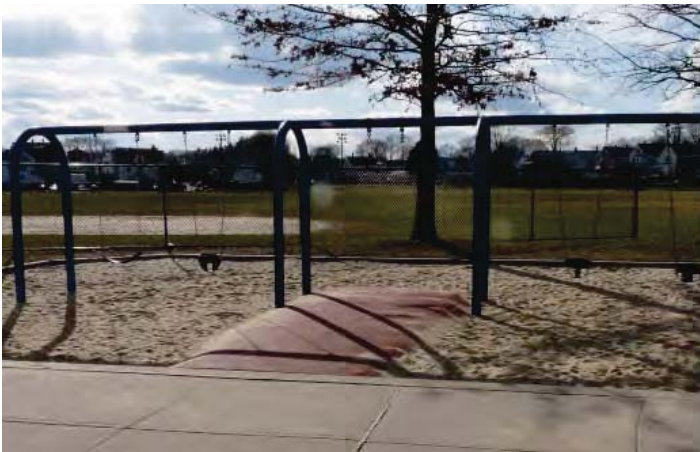
Existing Conditions Photo E - missing accessible swing

Missing accessible swing

A	Accessible Parking	install signs Striping	\$1500
B	Accessible Tables	replace min. 1 table with accessible table.	\$2,500
C	Accessible Swings	replace missing Swing	\$500
D	Accessible Play Structure	refill sand re-define planting edge	\$2,000
E	Accessible restrooms + Showers for pools	update bathrooms + Showers to meet current ADA codes

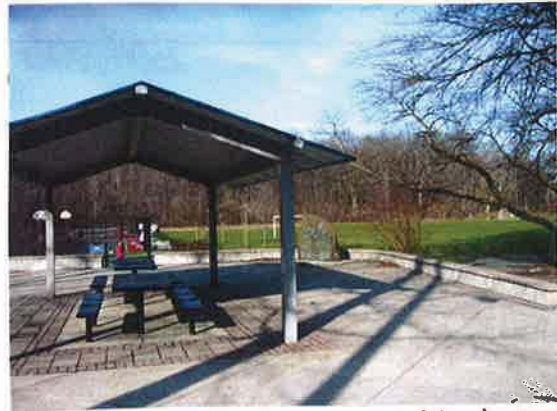
Potential table accessibility improvement

Key	Barrier	Mitigation	Cost
A	Accessible Table	replace	\$2,500
B	Accessible Pathways	upkeep/weed/ repack stone dust paths	\$5,000

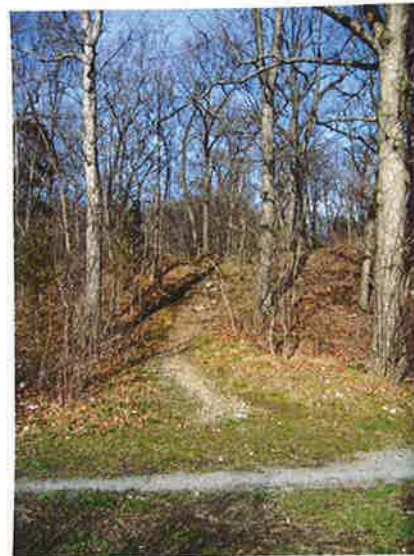
Path: repairs
repacking
paving?
