appendix B public meeting minutes

Medford Open Space & Recreation Plan 2011 Update
Public Hearing #1 - April 6th, 2011
Public Comments

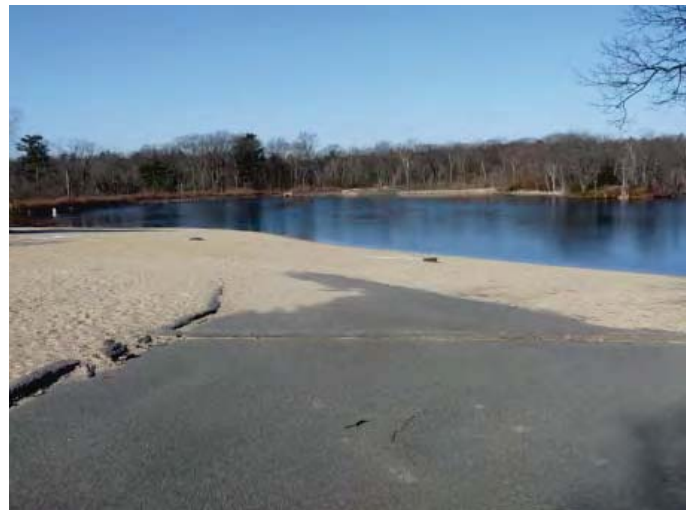
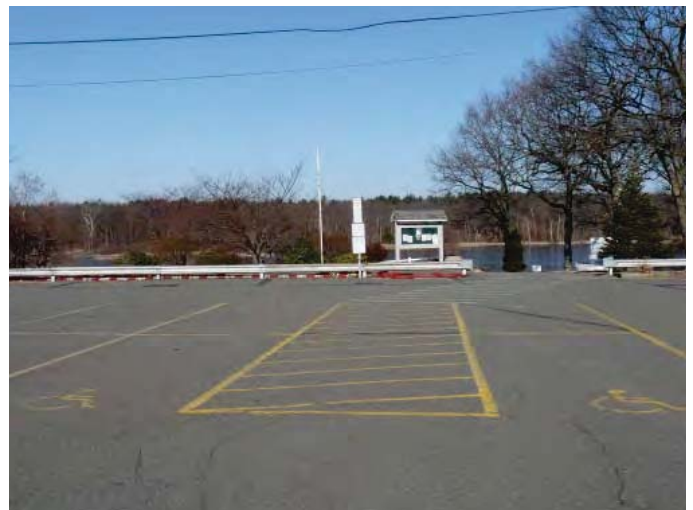
RELATED SKETCH/PHOTO

Asphalt "speed bump" (likely to prevent stormwater sheeting through the beach) prevents accessible access to the beach area - see photo below.
